SPECIAL INVESTIGATION REPORT

**ROBINSON HELICOPTER COMPANY R22 LOSS OF MAIN
ROTOR CONTROL ACCIDENTS**

**Adopted: April 2, 1996
Notation 6405B**

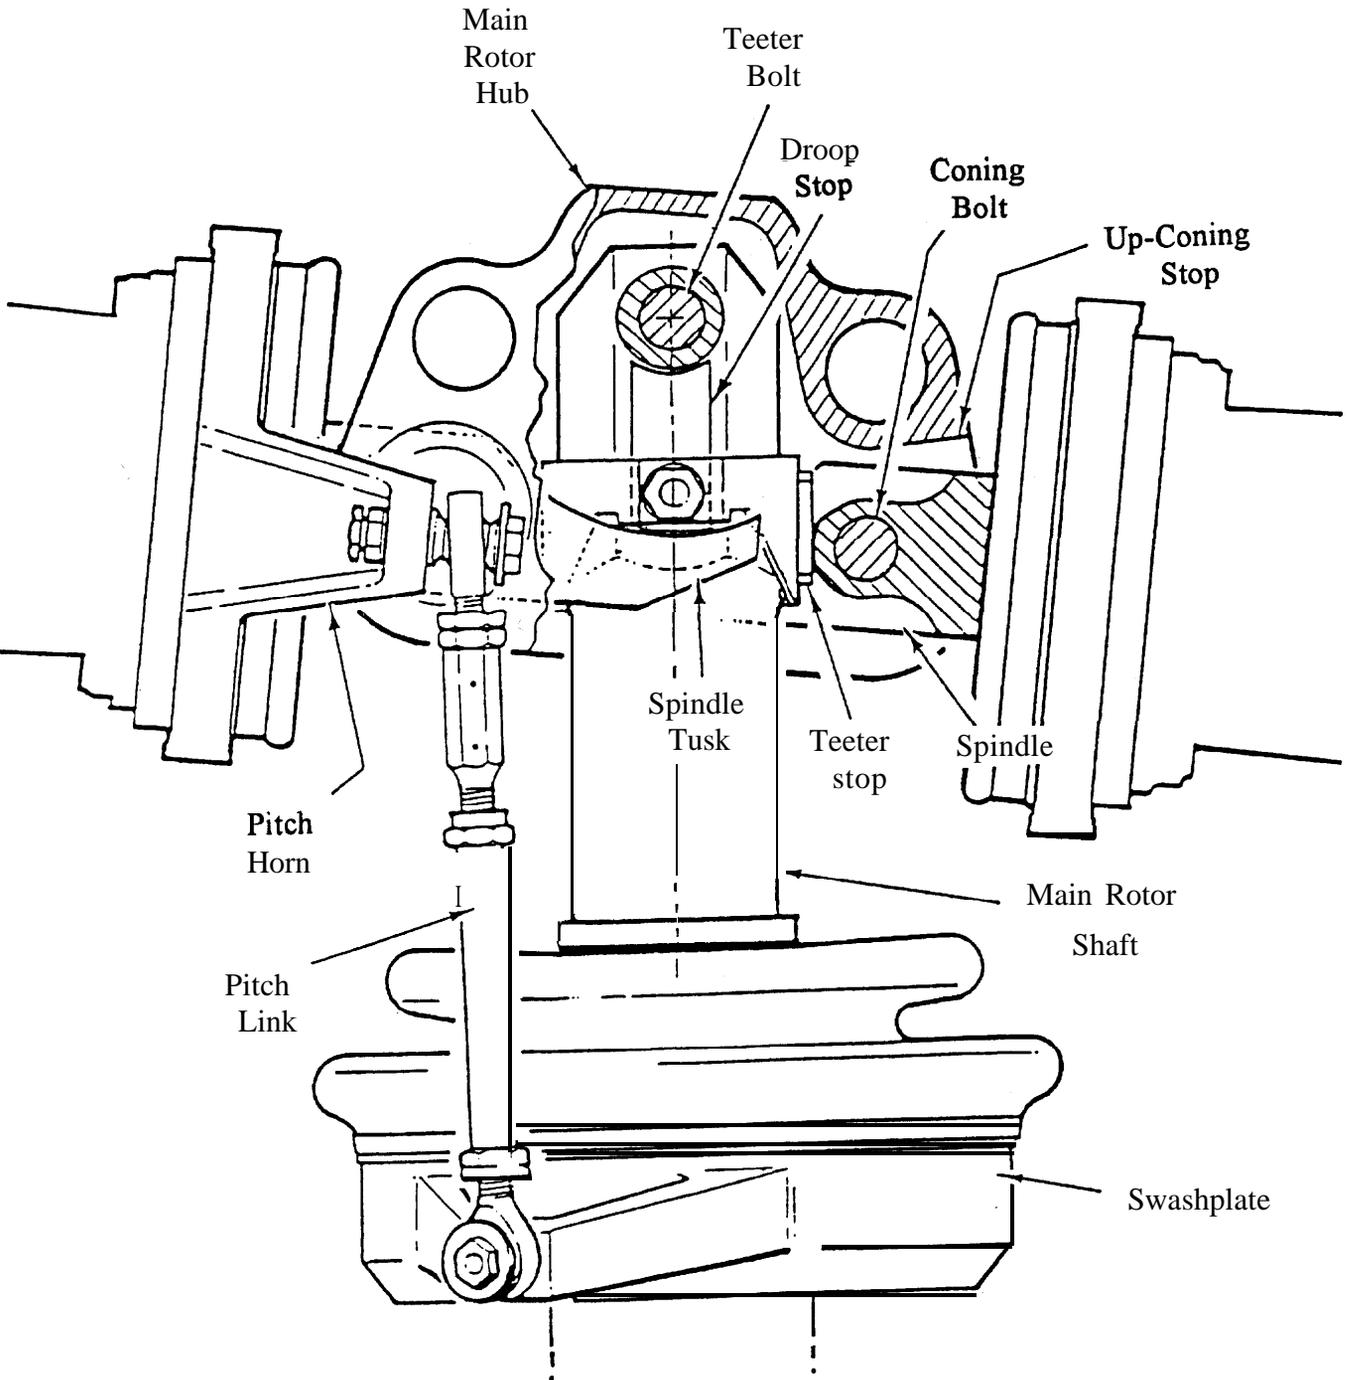
Figure 1 Main Rotor Hub and Assembly

³Pitch change links are metal links that connect the swashplate to the pitch horn of the blades to control the blade angle-of-attack. See Figure 1.

⁴A tusk is the inner portion of the blade spindle that contacts the droop stops during start-up or shut down. It is designed to prevent the blades from drooping too low when centrifugal and aerodynamic forces are too low to support the blade in the plane of rotation.

bay area) was not recovered. However, a main rotor blade had left its impression in the crushed left side of the tailboom's first bay area. Both pitch change links³ exhibited bending overload failures, and the spindle tusks⁴ were fractured from each spindle, consistent with damage resulting from the divergence of the main rotor blades from their normal plane of rotation. (Pitch change links and spindle tusks are addressed later in the report in Chapter 2.)

The main rotor system utilizes a two-blade, rigid-in-plane design.⁹ The rotor blades are connected to the main rotor hub (see Figure 1) through individual flapping hinges.¹⁰ The flapping hinges are part of a teetering main rotor hub that is hinged to the main rotor mast. In most two-bladed semi-rigid systems, the advancing blade flaps up, causing the retreating blade to flap down; however, the R22 main rotor blades are individually hinge-pinned and therefore can flap independently relative to each other. The total diameter of the R22 main rotor disc (two opposite blades connected by the hub) measures 25 feet, 2 inches, and each blade weighs approximately 26 pounds.

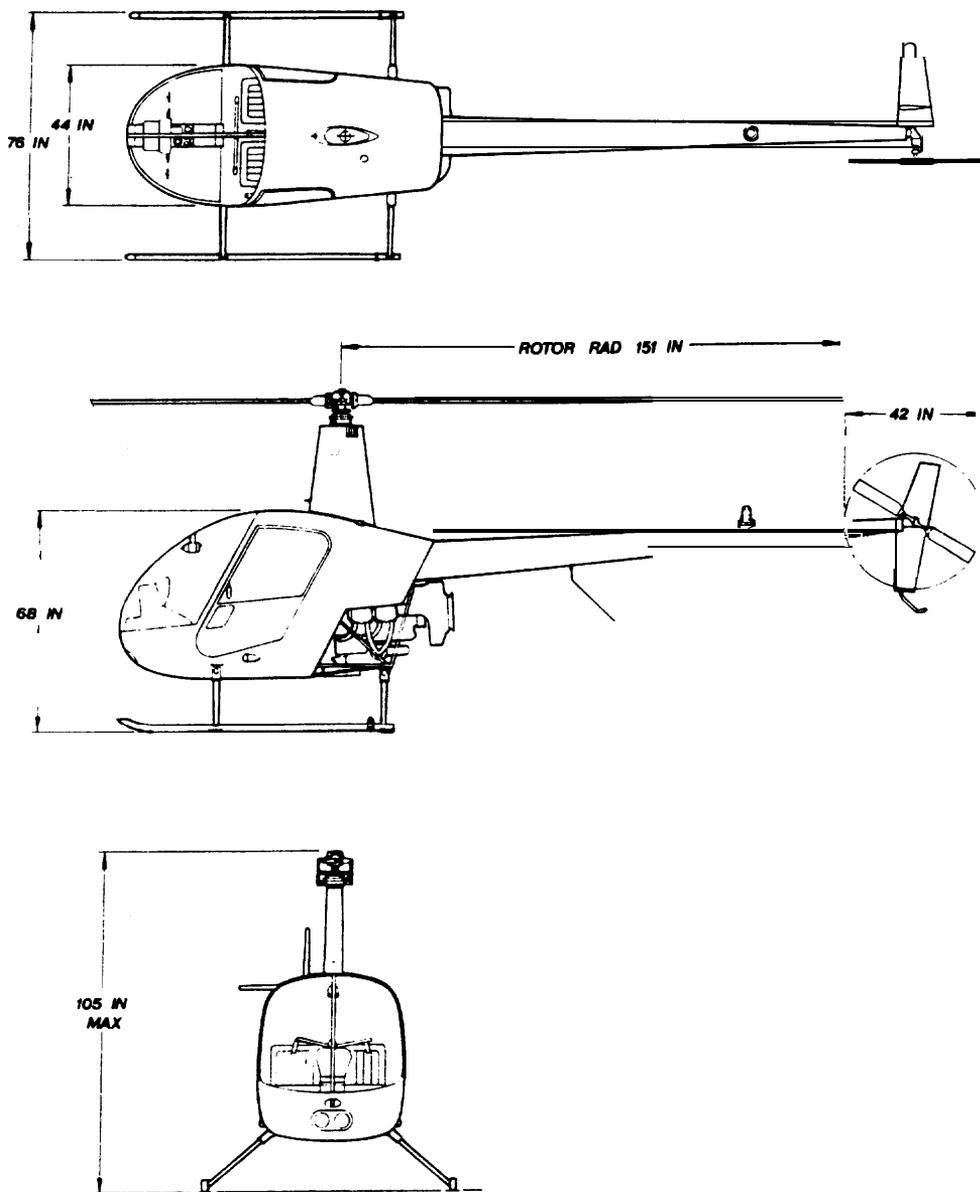
Figure 2--Three-Dimensional View of Robinson Helicopter Company

The Robinson R22 helicopter is a two-place, light utility aircraft powered by a four-cylinder Textron Lycoming O-320 reciprocating engine (see Figure 2). The helicopter has design features common to some helicopters but has several innovative design features unique to the R22 (and R44).

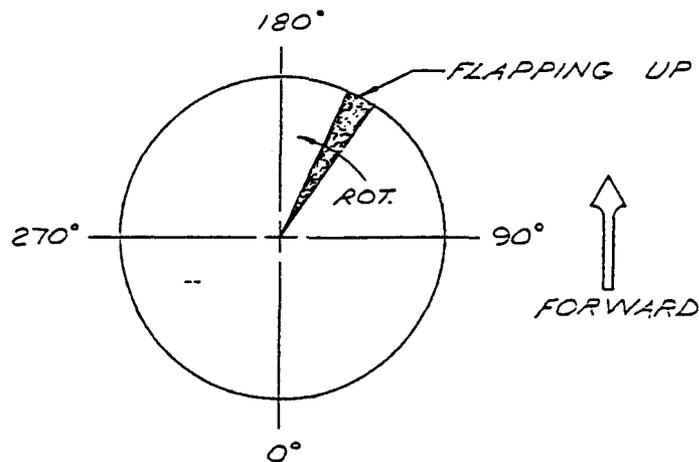
FLT. NO.	COND. NO.	DESCRIPTION	AZIMUTH LOCATION
6	27	LEVEL FLIGHT @ .9 V_{NE}	145.3°
6	37a	L. ROLL W/ 45° BANK @ .9 V_{NE}	155.5°
6	43a	R. ROLL W/ 45° BANK @ .9 V_{NE}	140.9°
6	23	LEVEL FLIGHT @ .6 V_{NE}	152.7°
6	35a	L. ROLL W/ 45° BANK @ .6 V_{NE}	152.7°
6	41a	R. ROLL W/ 45° BANK @ .6 V_{NE}	153.9°

ALL MANEUVERS PERFORMED AT 97% RPM

APPENDIX C-Main Rotor Hub Teeter Angle and Rpm Decay Survey
